## Scanning Electron Microscope & Energy Dispersive X-Ray Spectrometer Analysis of Samples Cleaned with CleanWirx

Loren L. Hatle, NACE Level 3, CIP Cert. #207, CTO

Spectroscopy Services Provided by Anastas Technical Services

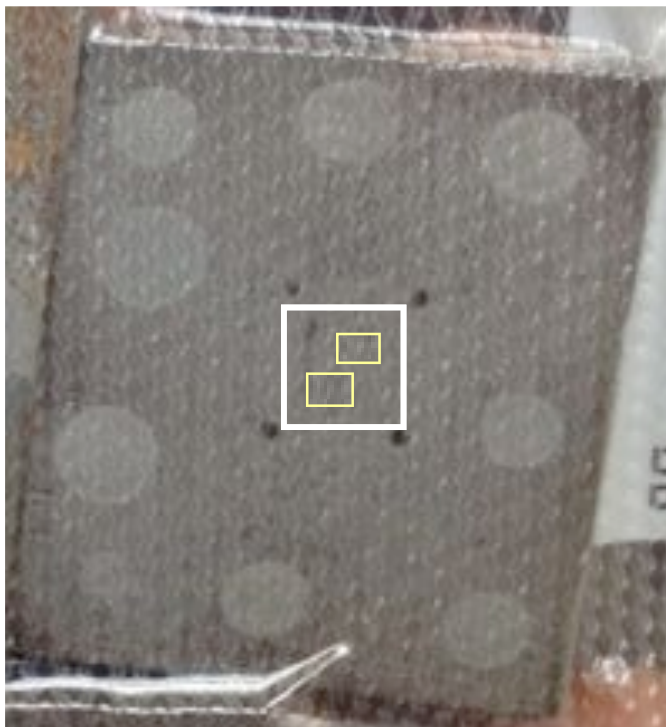
#1

Sample 1 was uniformly decontaminated with CLEANWIRX and then saturated with Ferric Chloride solution across the entire face and then a grain of Sulfur was deposited right in the center. The first image is a picture of the actual sample. Although the picture was taken after it had been vacuum sealed in a plastic bag for shipment, the Sulfur field is still evident through the plastic (see the slight / light colored circle about the size of a pencil eraser between all four dots and slightly larger than the white box).

The objective was to observe an area known to be populated with Sulfur particles. Four dots were placed around the Sulfur field to indicate where to inspect / image.

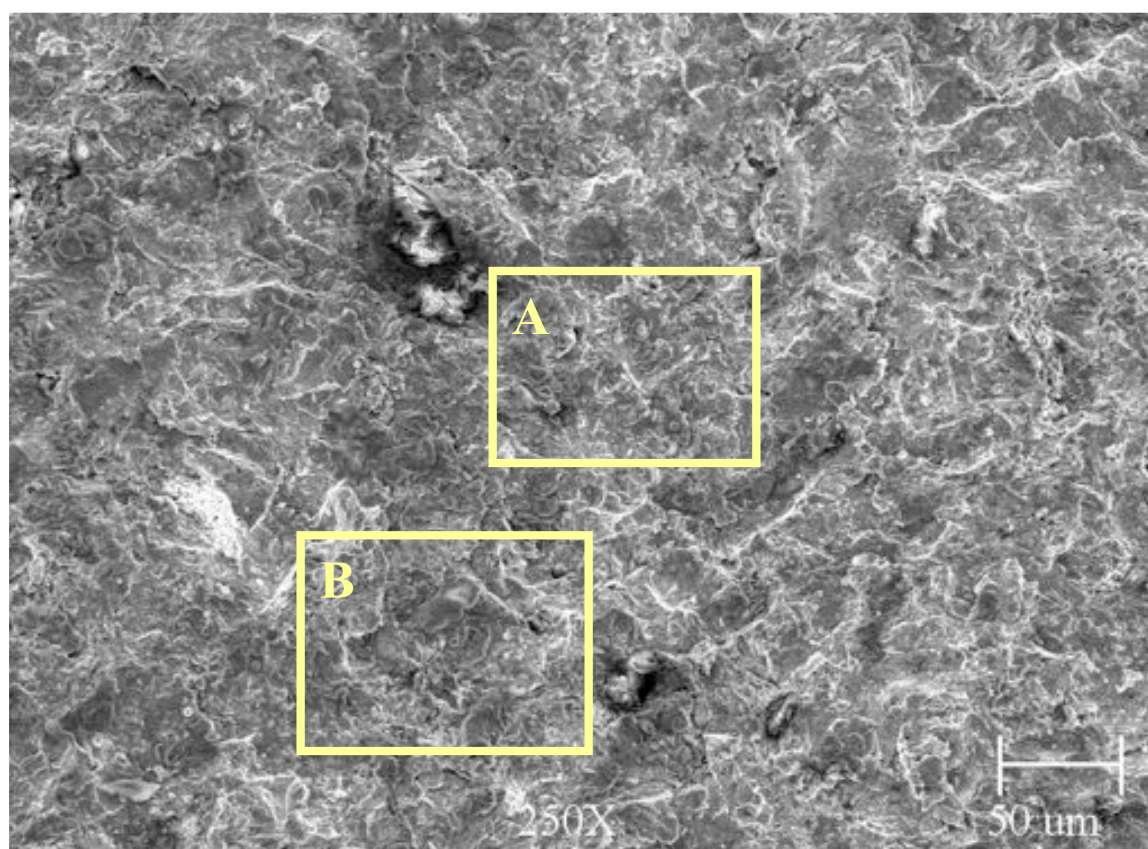
#2

Mr. Anastas looked in a handful of regions in this field and everywhere he inspected he found deposits of Sulfur and Chlorine. The first magnified image (image 2) was taken at 250x and two additional inspection fields (A & B) were each imaged at 1000x (see images 3 & 4).

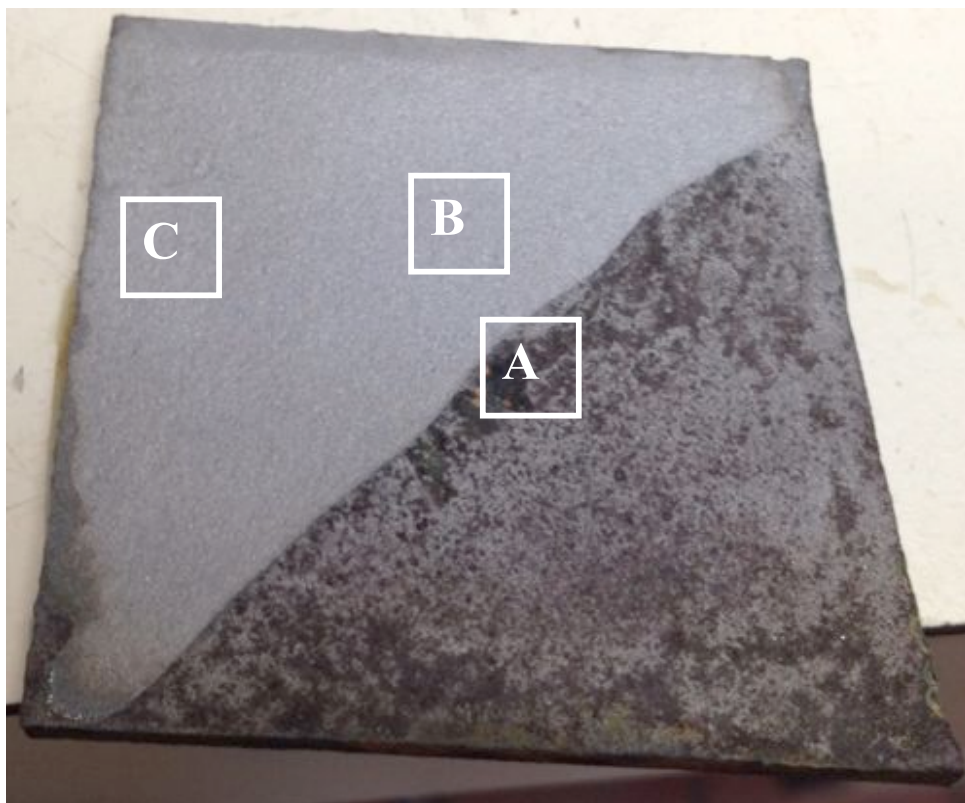
#5

Sample 2 was uniformly decontaminated with CLEANWIRX and then saturated with Sulfur followed by Ferric Chloride solution. The sample was then cleaned in a diagonal cross section forming two triangular shaped fields – one contaminated, one decontaminated.

Multiple regions were analyzed (See Image 5) but only three (Fields A, B & C) were recorded as they were representative of all the unrecorded inspections on both samples.

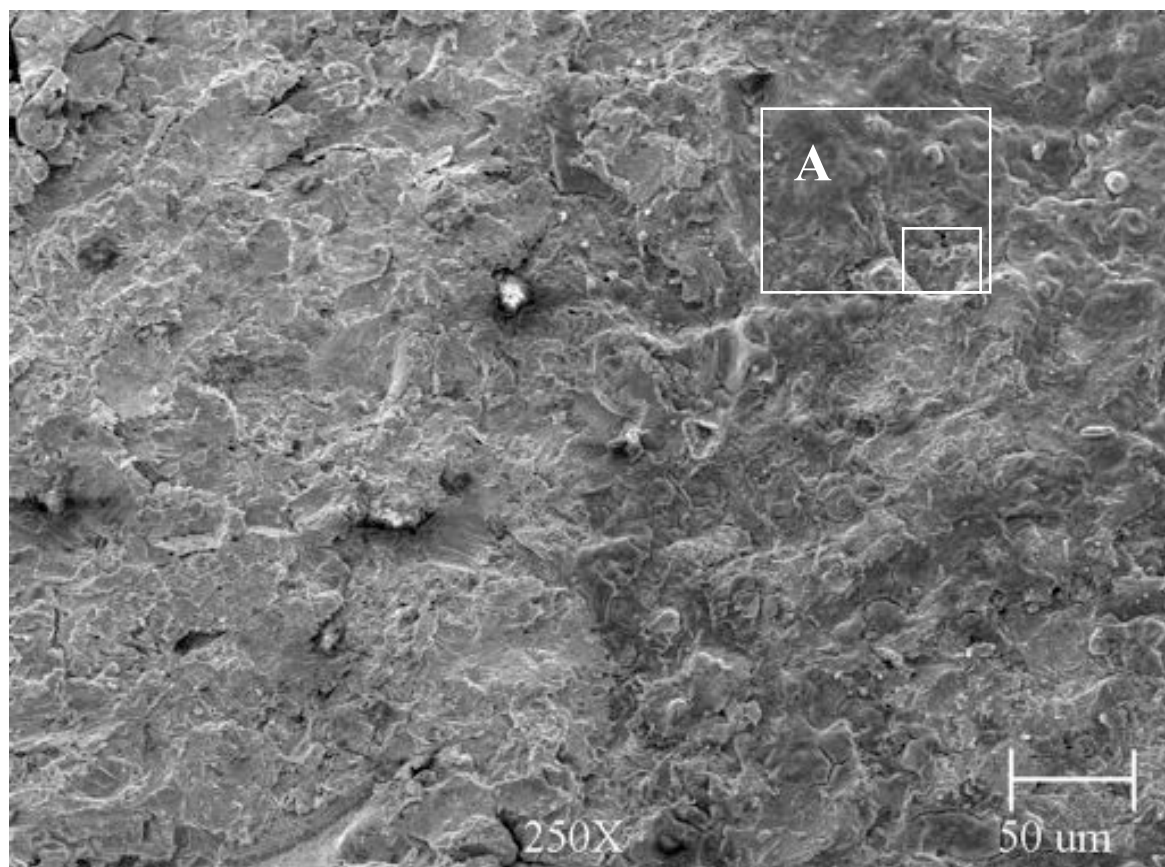
#6

Field A: A known contaminated area, High Sulfur and Chlorine were identified immediately with no searching.

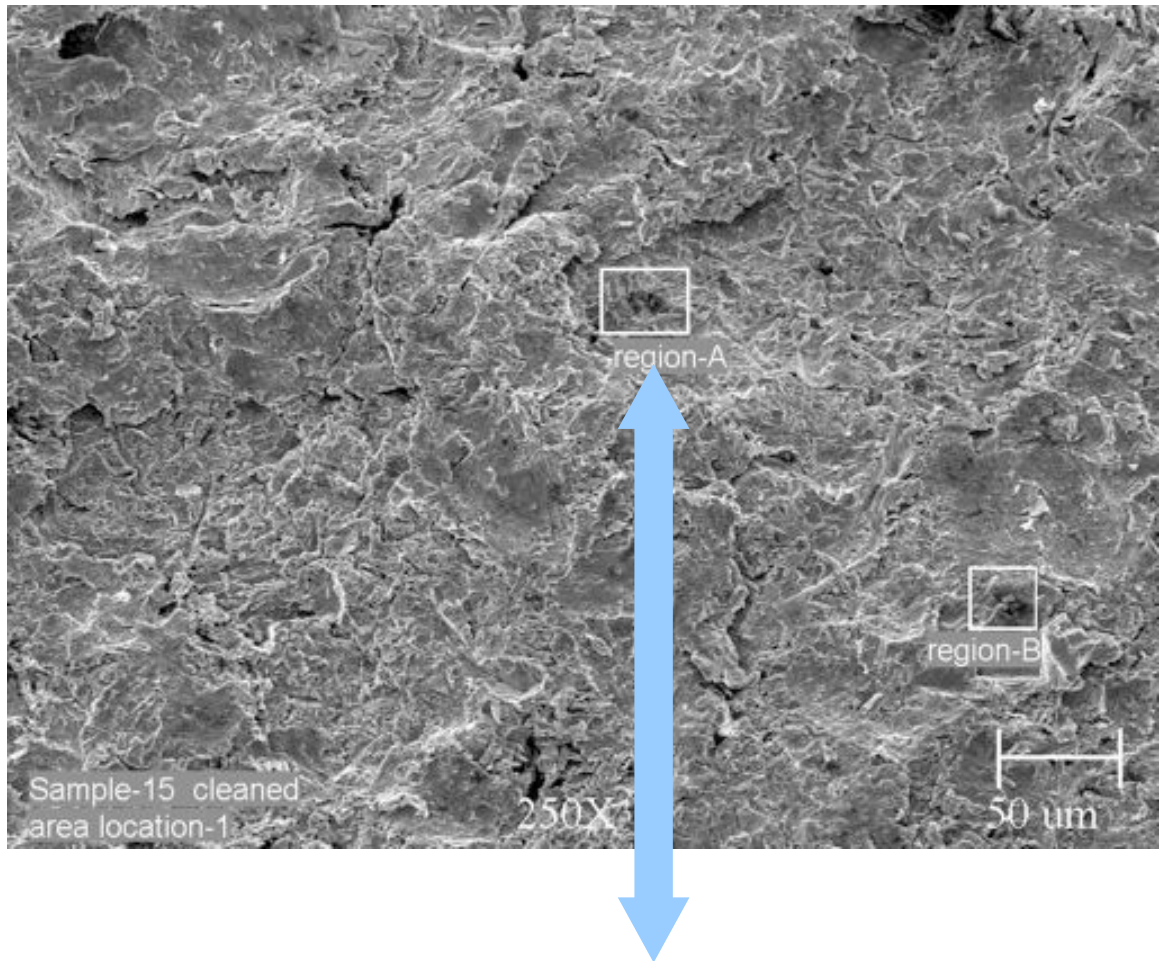
#9

Fields B & C: Decontaminated Side, both fields were visibly different from Sample 1 and Sample 2, Field A. Except for embedded abrasive material (Aluminum Oxide), no Sulfur or Chlorine sites were identified.
