## Scanning Electron Microscope & Energy Dispersive X-Ray Spectrometer Analysis of Samples Cleaned with CleanWirx

Loren L. Hatle, NACE Level 3, CIP Cert. #207, CTO

Spectroscopy Services Provided by Anastas Technical Services

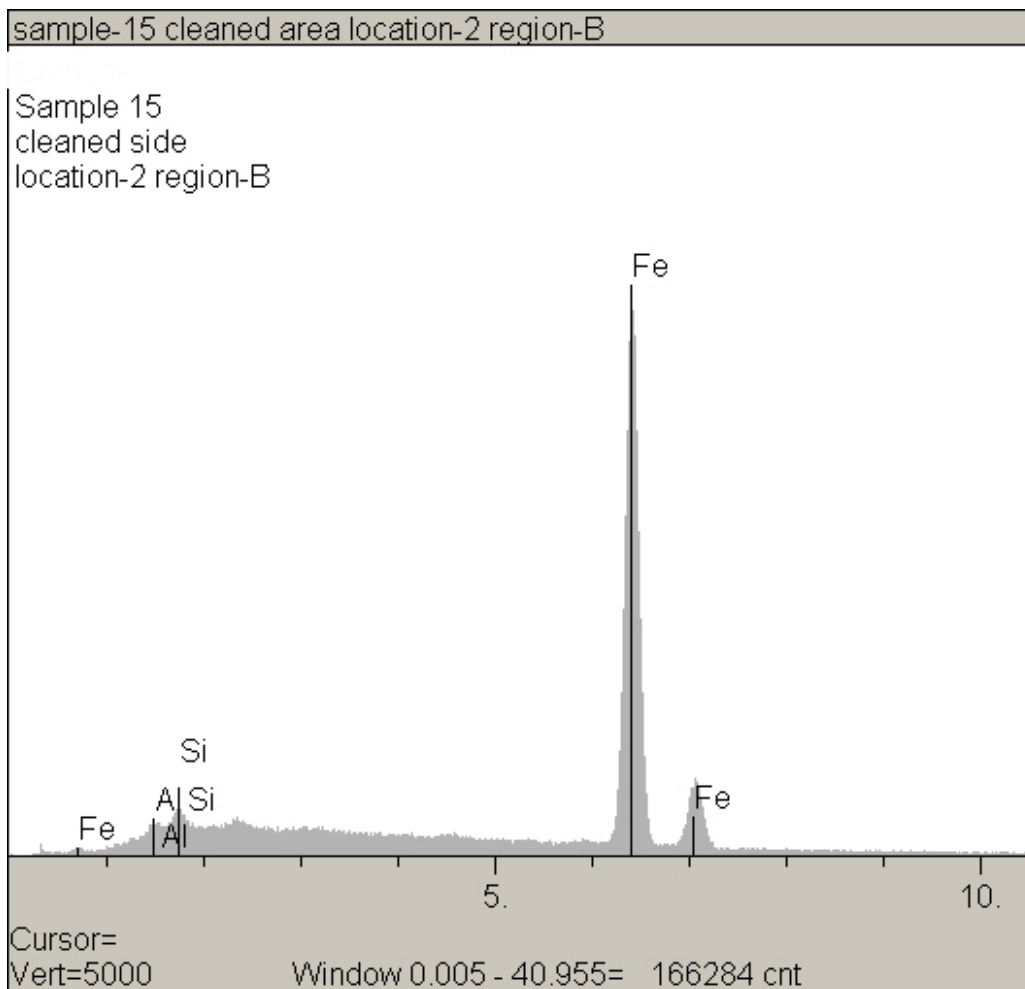
## Sample #2, EDS Report, Field C, Region B

Elt.	Line	Intensity (c/s)	Error 2-sig	Conc	Units	
Al	Ka	14.59	0.986	1.359	wt.%	
Si	Ka	28.54	1.379	2.022	wt.%	
Fe	Ka	973.30	8.055	96.619	wt.%	
				100.000	wt.%	Total

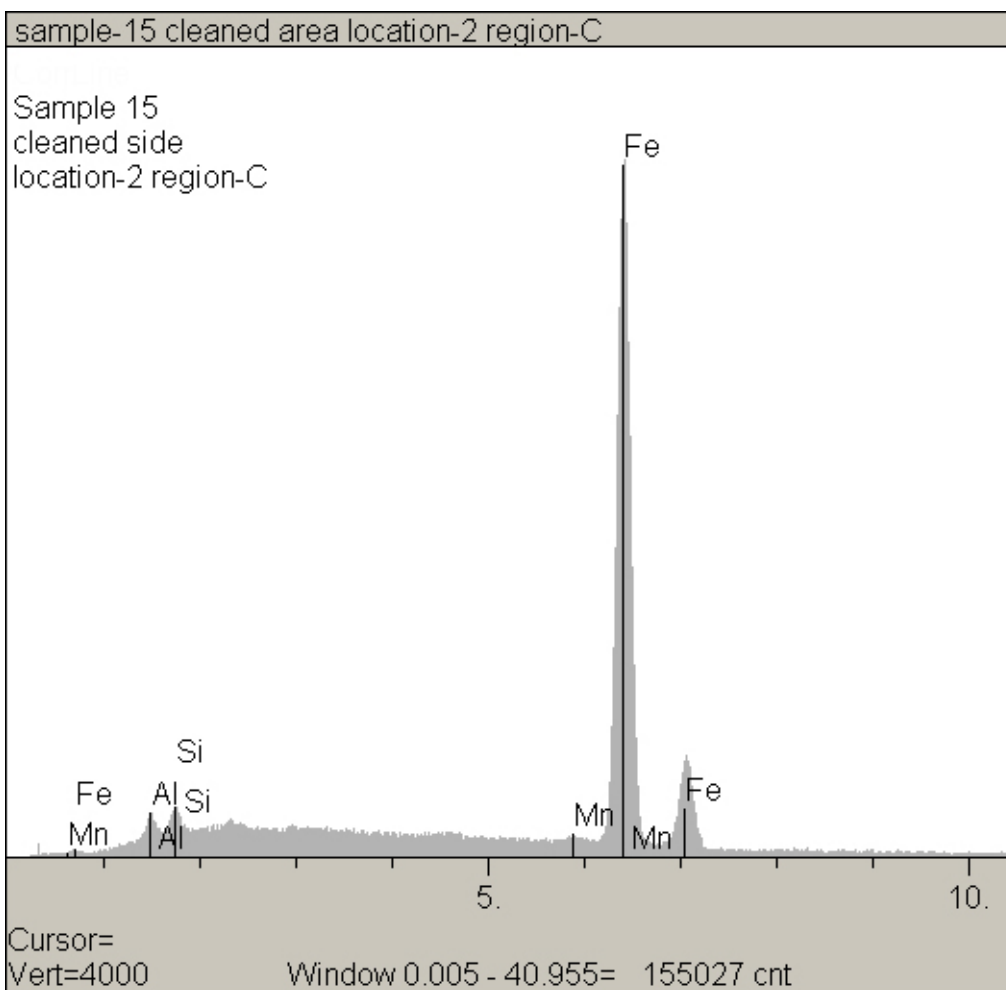
## Sample #2, EDS Report, Field C, Region C

Elt.	Line	Intensity (c/s)	Error 2-sig	Conc	Units	
Al	Ka	19.80	1.149	1.842	wt.%	
Si	Ka	23.96	1.264	1.705	wt.%	
Mn	Ka	5.86	0.625	0.327	wt.%	
Fe	Ka	967.93	8.033	96.126	wt.%	
				100.000	wt.%	Total
